COMBINED FIRE AND HEALTH & SAFETY RISK ASSESSMENT.

Address of premises:	1-7 Mary Floyd Flats 15 Milton Road Swindon SN1 5JE
Responsible Person:	Mary Floyd House Management Company Limited
Duty Holder:	Block Management Limited
Person(s) consulted:	No occupier or other relevant person available to consult.
Assessor:	Rob Cockburn
Report validated by:	John Godfrey, GFireE.
Date of fire risk assessment:	31 st October 2025
Date of previous fire risk assessment:	September 2023
Suggested date for review:	October 2026

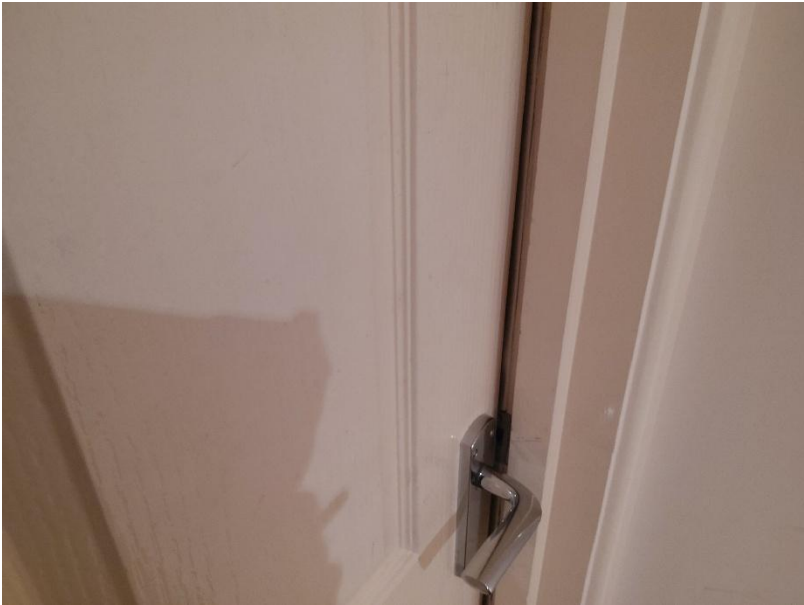
Item	Recommendation	Priority	Timescale
01	<p>It was noted during this fire risk assessment that the identified communal area doors had the following deficiency:</p> <ul style="list-style-type: none"> • Second floor lobby door does not fully self-close <p>It is essential that each door communicating with the means of escape is a suitable fire door, providing a minimum of thirty minutes fire resistance, hung on three grade 13 hinges, combine cold smoke and intumescent seal, "Fire Door Keep Locked" or "Fire Door Keep Shut" signage where appropriate along with having a functioning self-closing device fitted that positively closes the door flush to the frame if a lobby door. It is recommended therefore that the RP instruct a suitably qualified and competent contractor to conduct a fire door inspection to all communal area doors providing advice on suitability as per "Fire Resisting Doors - 62.17" of Fire Safety in Purpose-Built Block of Flats. Any shortcomings identified by this inspection should be addressed as a priority by upgrading or replacing the door.</p> <p>Flat entrance doors, communal area doors, the seals and the self-closing devices should then be subjected to an annual inspection and maintenance schedule.</p>

Action required
Contractor to action
